QUIET CLEAN SHORT-HAUL EXPERIMENTAL ENGINE (OCSEE)
UNDER-THE-WING (UWU)
ENGINE COMPOSITE NACELLE TEST REPORT

Volume I - Summary, Aerodynamic and Mechanical Performance

APRIL 1979

Advanced Engineering and Technology Programs Department
Aircraft Engine Engineering Division

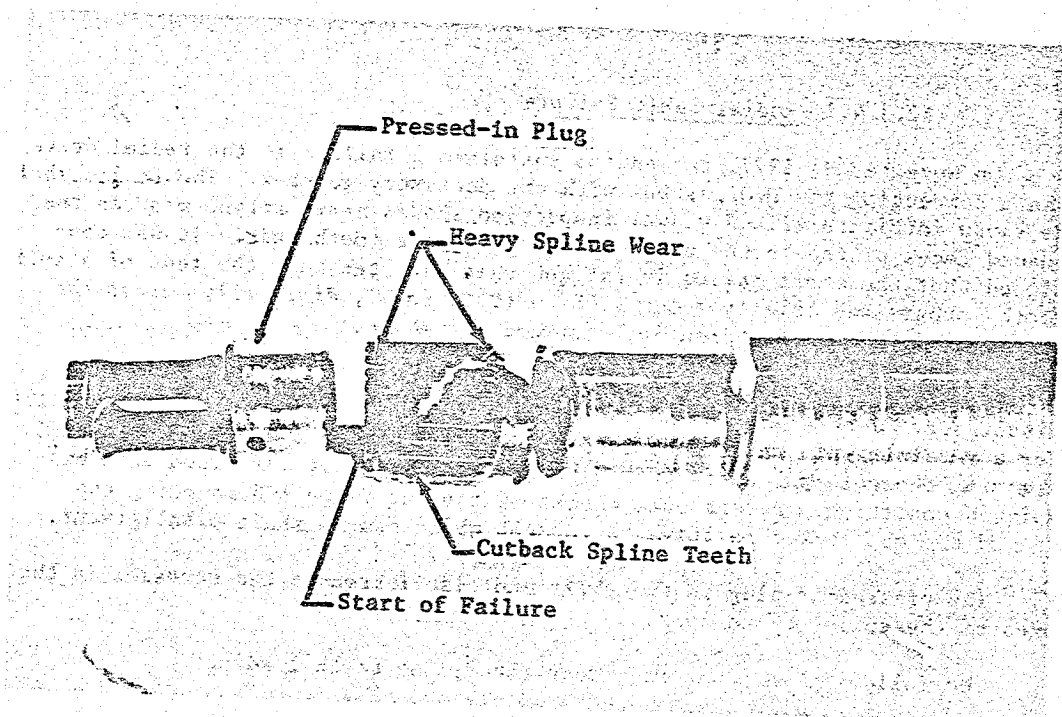
Figure 41. Radial Drive Shaft Failure.

12.3.4.1 Radial Shaft Failure

After installing the modified shaft, testing was completed without incidence.

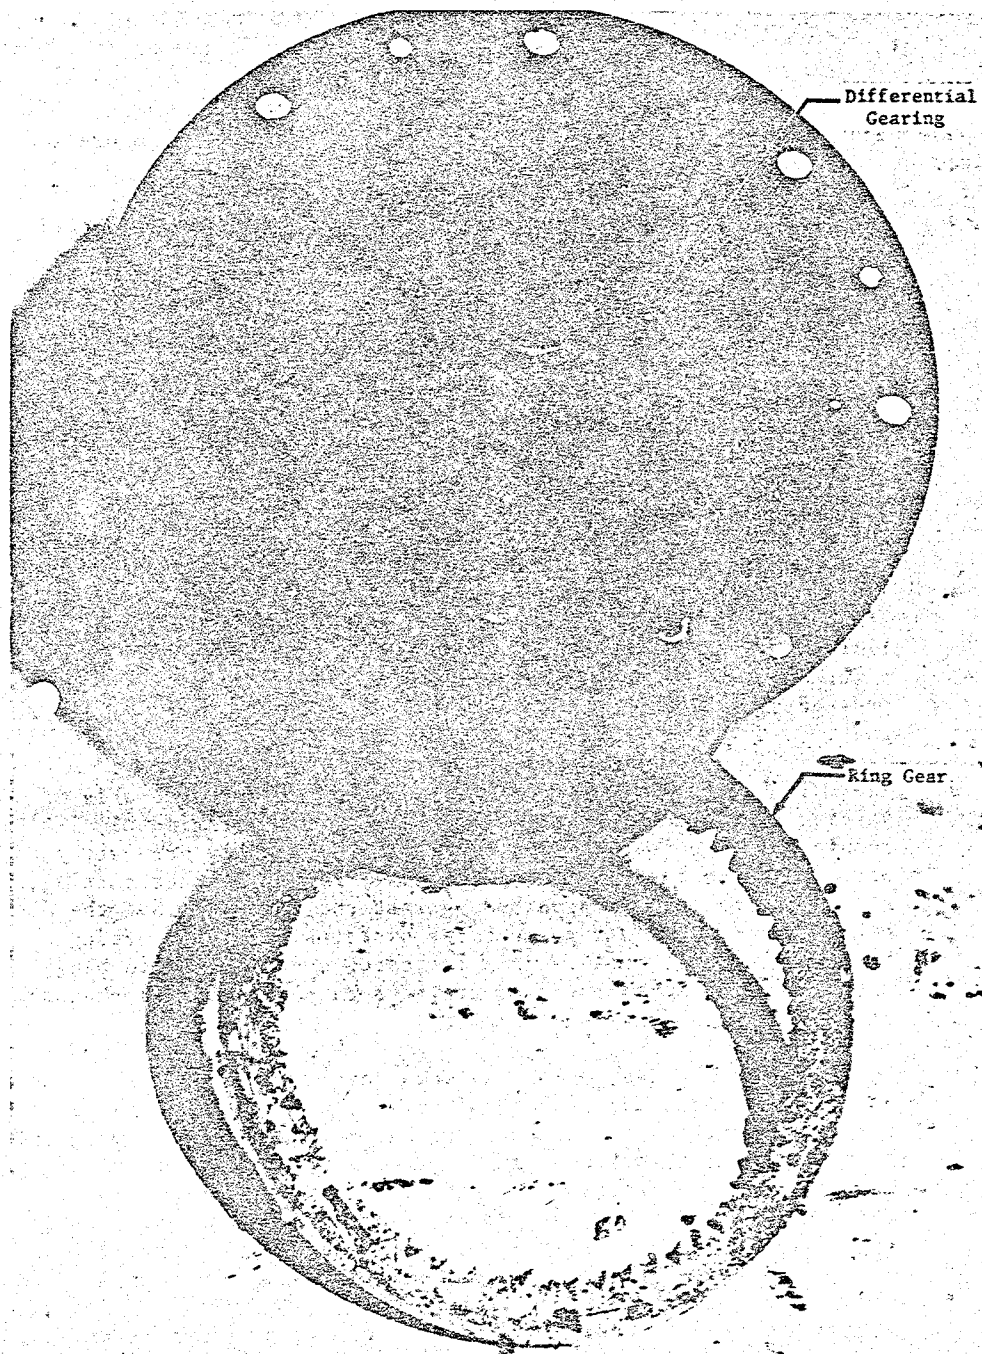
Figure 79. Variable Pitch Differential Gearing.

On 3/11/78, the fan actuator was removed from the engine revealing that the differential assembly had failed and was heavily damaged. It was removed

The new differential hardware was installed and a mechanical checkout was made with no problems.
